Marlborough Town Council

Property Committee

Asbestos Management Survey for

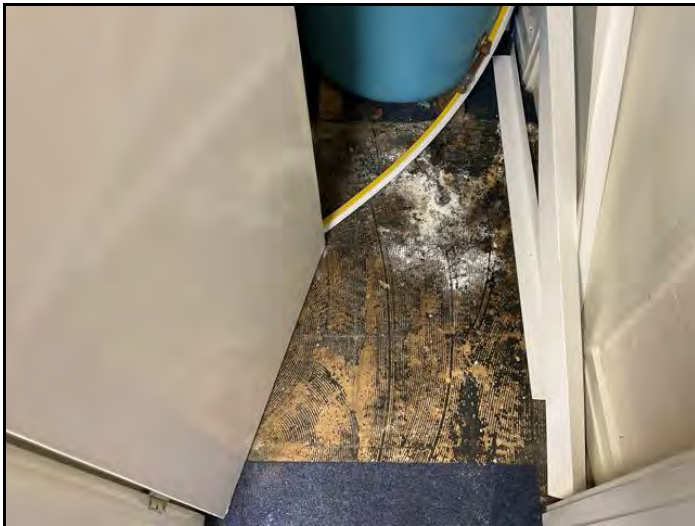
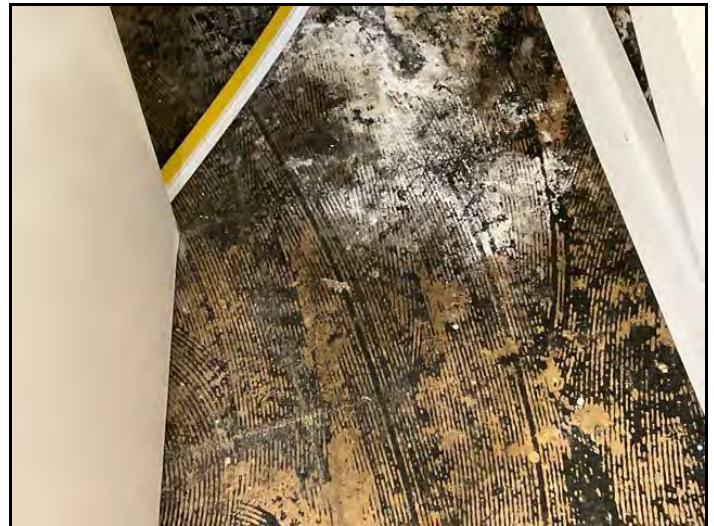
Sample Number	Presumed	Survey Type	MS
Location Ref	002	Product Type	Bituminous Product
Product	Adhesive to floor	Damage	Low Damage
Area	Marlborough Community & Youth Centre	Surface Treatment	Composite, plastics or resins
Floor	Basement	Asbestos Type	Chrysotile
Room	Music room	Identification	Presumed
Surveyor Name	Rob Letman	Quantity	2 m ²
Asbestos?	Yes	Material Risk Score	3
Date	18/06/2024	Material Risk Band	Very Low
Next Inspection	18/06/2025	Priority Risk Score	0
Action	Affix ID Labels & Manage as part of the management plan

Asbestos material is currently in a fair condition. Strongly recommended the material should have periodic inspections undertaken to manage the material in situ & where possible have asbestos warning stickers applied. A annual re-inspection asbestos survey is recommended. The ongoing management of the asbestos material will need to be undertaken in accordance with current control of asbestos regulations 2012.

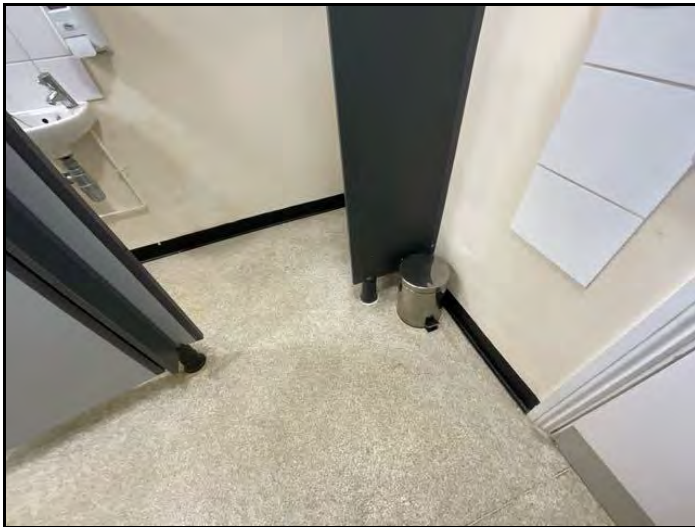
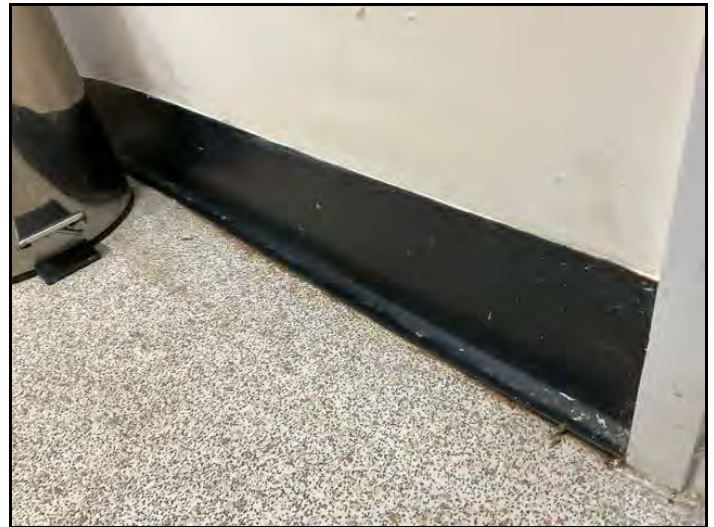
Sample Number	S001	Survey Type	MS
Location Ref	005	Product Type	Vinyl Products
Product	Vinyl upstands	Damage	Not Applicable
Area	Marlborough Community & Youth Centre	Surface Treatment	Not Applicable
Floor	Basement	Asbestos Type	NAD
Room	Male & Female w.c	Identification	
Surveyor Name	Rob Letman	Quantity	
Asbestos?	No	Material Risk Score	0
Date	18/06/2024	Material Risk Band	Not Applicable
Next Inspection	Not Applicable	Priority Risk Score	Not Applicable
Action	No Action Required

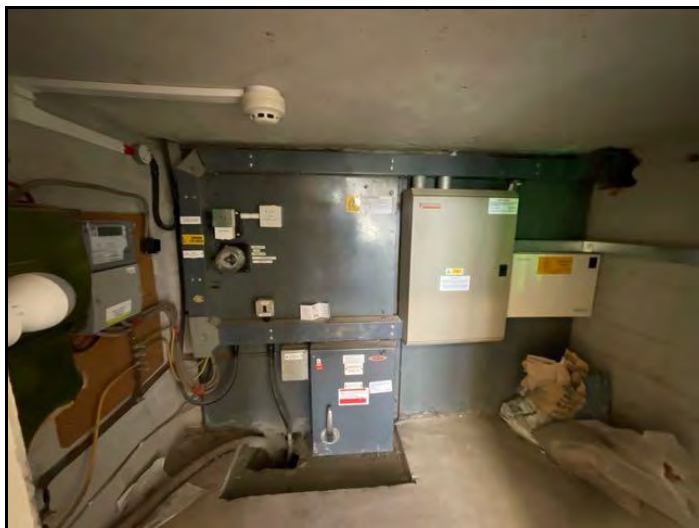
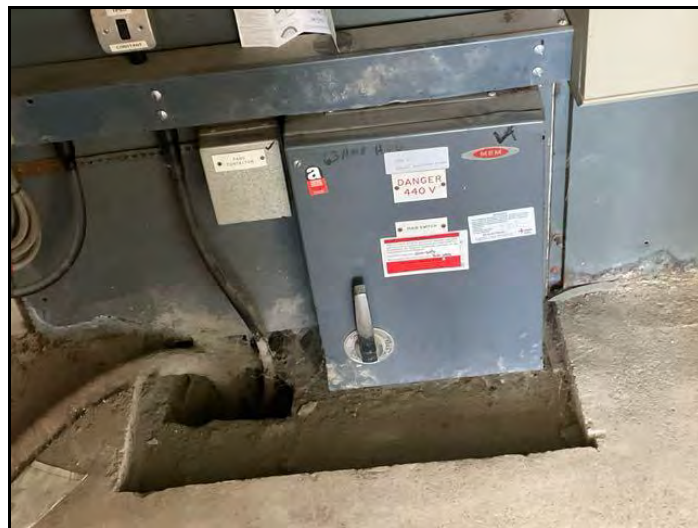
Sample Number	Strongly Presumed	Survey Type	MS
Location Ref	006	Product Type	Limited Access Gained
Product	Electrical boxes	Damage	Low Damage
Area	Marlborough Community & Youth Centre	Surface Treatment	Sealed AIB, spray, textile and thermal insulation, or asbestos cement
Floor	Basement	Asbestos Type	Chrysotile
Room	Electrical store	Identification	Strongly Presumed
Surveyor Name	Rob Letman	Quantity	1 box
Asbestos?	Yes	Material Risk Score	4
Date	18/06/2024	Material Risk Band	Very Low
Next Inspection	18/06/2025	Priority Risk Score	0
Action	Affix ID Labels & Manage as part of the management plan

Asbestos material is currently in a fair condition. Strongly recommended the material should have periodic inspections undertaken to manage the material in situ & where possible have asbestos warning stickers applied. A annual re-inspection asbestos survey is recommended. The ongoing management of the asbestos material will need to be undertaken in accordance with current control of asbestos regulations 2012.

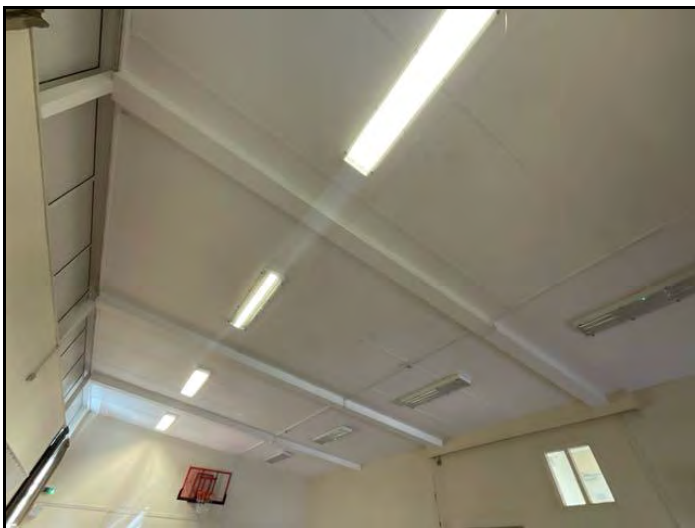
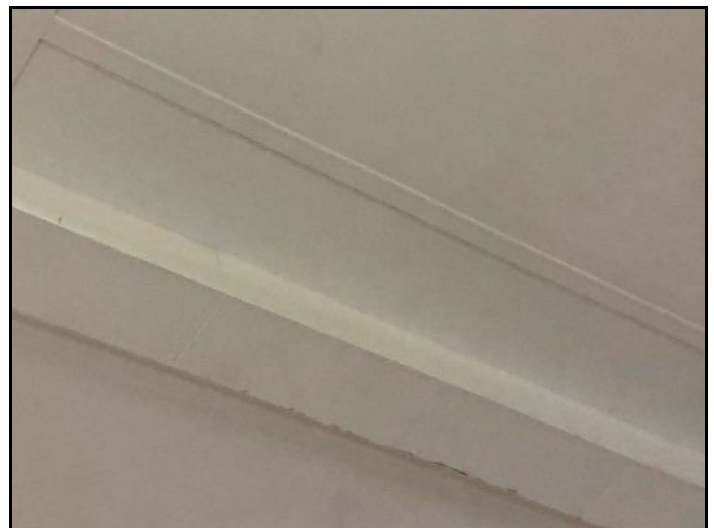
Sample Number	Presumed	Survey Type	MS
Location Ref	010	Product Type	Insulating Board
Product	Ceiling & boxing	Damage	Good Condition
Area	Marlborough Community & Youth Centre	Surface Treatment	Sealed AIB, spray, textile and thermal insulation, or asbestos cement
Floor	Ground Floor	Asbestos Type	Crocidolite
Room	Hall	Identification	Presumed
Surveyor Name	Rob Letman	Quantity	All area
Asbestos?	Yes	Material Risk Score	4
Date	18/06/2024	Material Risk Band	Very Low
Next Inspection	18/06/2025	Priority Risk Score	0
Action	Sample to confirm the presence of Asbestos prior to any refurbishment works

No Access to high level ceiling and boxings - further inspection and sampling required when access is provided.

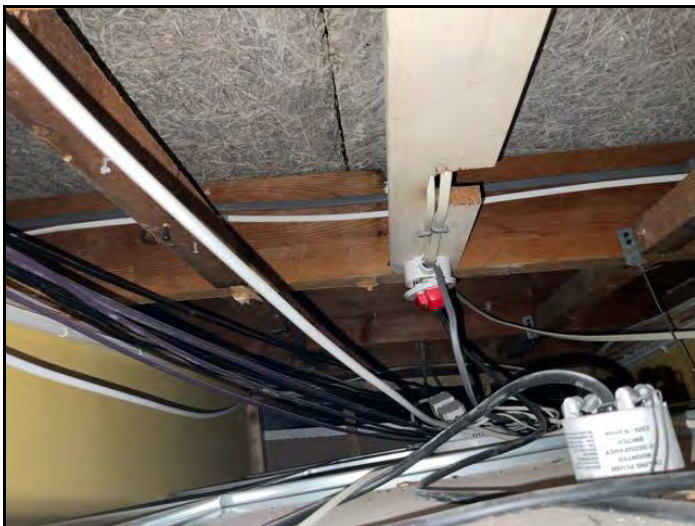
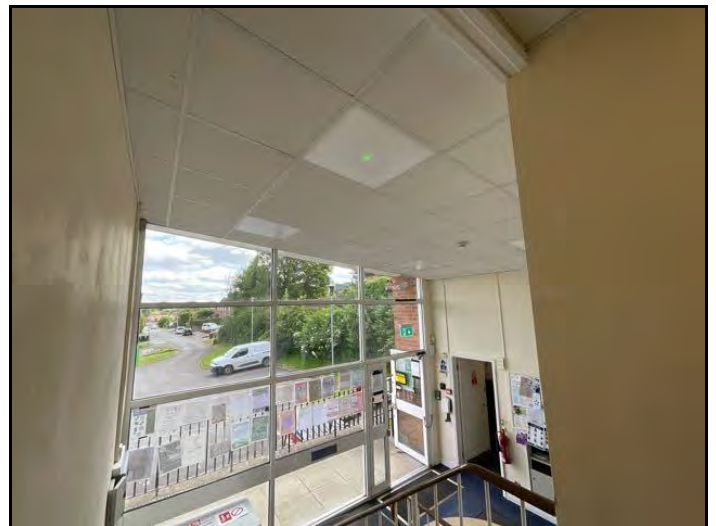
Sample Number	X002	Survey Type	MS
Location Ref	011	Product Type	Paper Product
Product	Debris to timbers	Damage	High Damage
Area	Marlborough Community & Youth Centre	Surface Treatment	Unsealed AIB, encapsulated spray
Floor	1st Floor	Asbestos Type	Chrysotile
Room	Ceiling void	Identification	Cross Reference
Surveyor Name	Rob Letman	Quantity	52 m ²
Asbestos?	Yes	Material Risk Score	8
Date	18/06/2024	Material Risk Band	Medium
Next Inspection	18/06/2025	Priority Risk Score	0
Action	Restrict access and remove by a licensed contractor

The asbestos material is currently in a poor condition and requires either removal or repair/encapsulation as soon as practically possible. The remedial works must be undertaken in accordance with current control of asbestos regulations 2012.

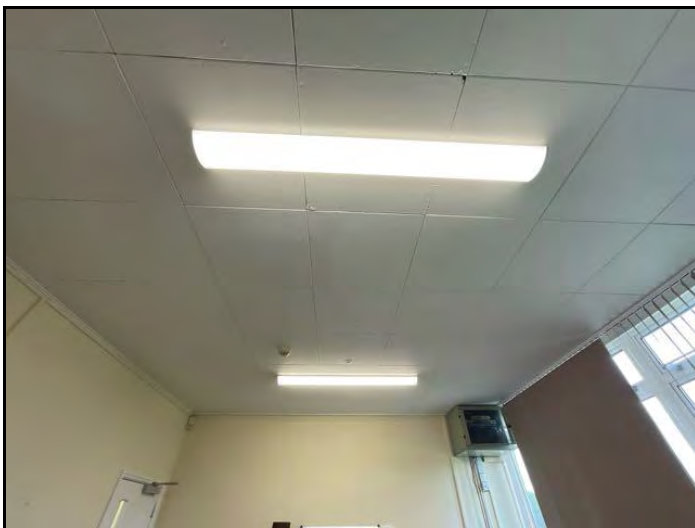
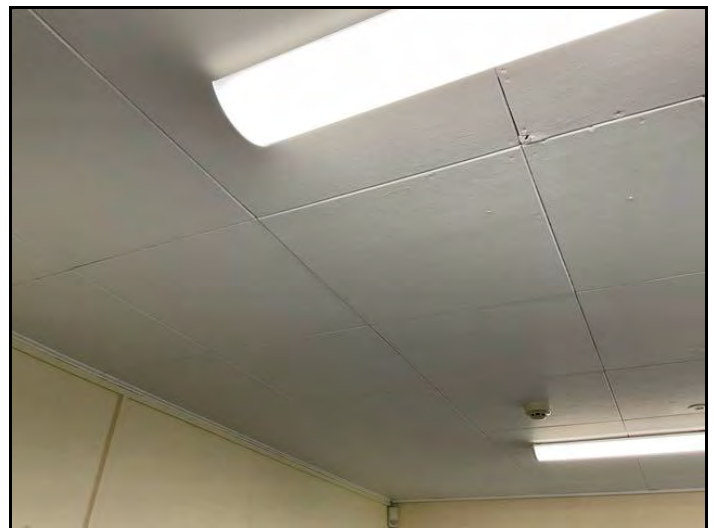
Sample Number	S002	Survey Type	MS
Location Ref	013	Product Type	Paper Product
Product	Ceiling	Damage	Low Damage
Area	Marlborough Community & Youth Centre	Surface Treatment	Sealed AIB, spray, textile and thermal insulation, or asbestos cement
Floor	1st Floor	Asbestos Type	Chrysotile
Room	Office	Identification	Identified
Surveyor Name	Rob Letman	Quantity	32 m ²
Asbestos?	Yes	Material Risk Score	5
Date	18/06/2024	Material Risk Band	Low
Next Inspection	18/06/2025	Priority Risk Score	0
Action	Affix ID Labels & Manage as part of the management plan

Asbestos material is currently in a fair condition. Strongly recommended the material should have periodic inspections undertaken to manage the material in situ & where possible have asbestos warning stickers applied. An annual re-inspection asbestos survey is recommended. The ongoing management of the asbestos material will need to be undertaken in accordance with current control of asbestos regulations 2012.

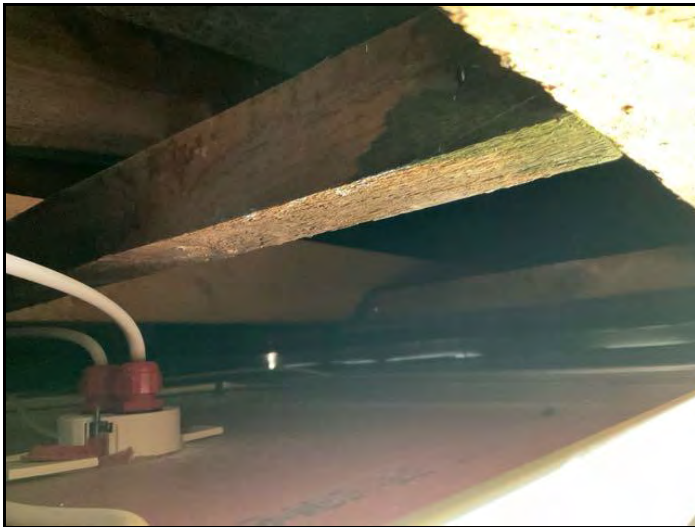
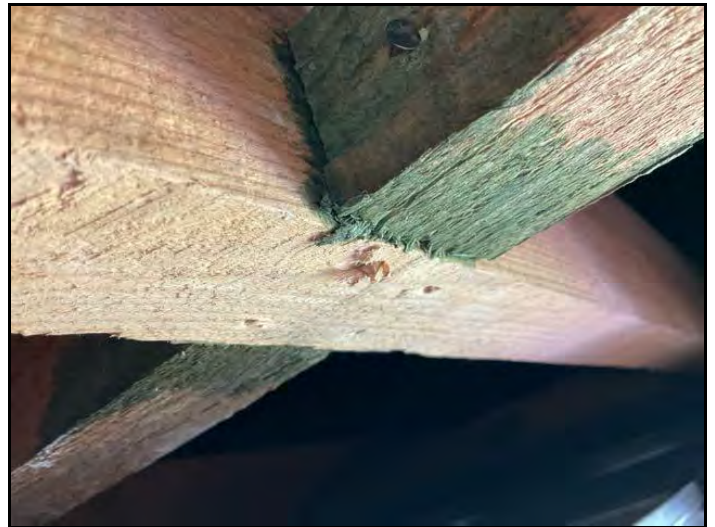
Sample Number	X002	Survey Type	MS
Location Ref	014	Product Type	Paper Product
Product	Debris to timbers	Damage	Medium Damage
Area	Marlborough Community & Youth Centre	Surface Treatment	Unsealed AIB, encapsulated spray
Floor	1st Floor	Asbestos Type	Chrysotile
Room	Kitchen	Identification	Cross Reference
Surveyor Name	Rob Letman	Quantity	21 m ²
Asbestos?	Yes	Material Risk Score	7
Date	18/06/2024	Material Risk Band	Medium
Next Inspection	18/06/2025	Priority Risk Score	0
Action	Restrict access and remove by a licensed contractor

The asbestos material is currently in a poor condition and requires either removal or repair/encapsulation as soon as practically possible. The remedial works must be undertaken in accordance with current control of asbestos regulations 2012.

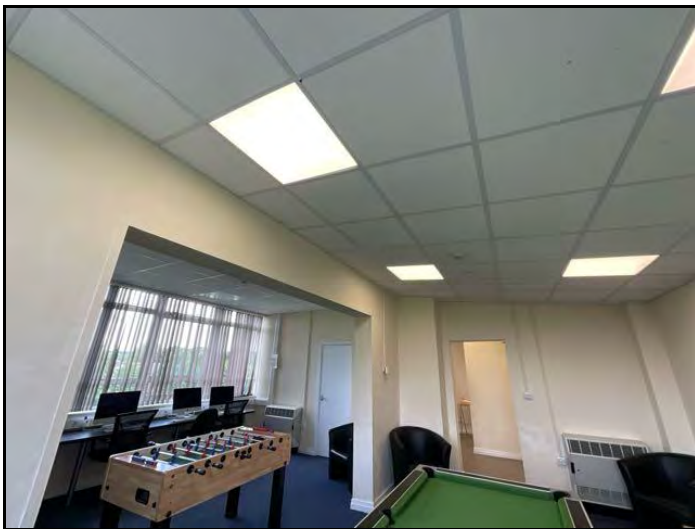
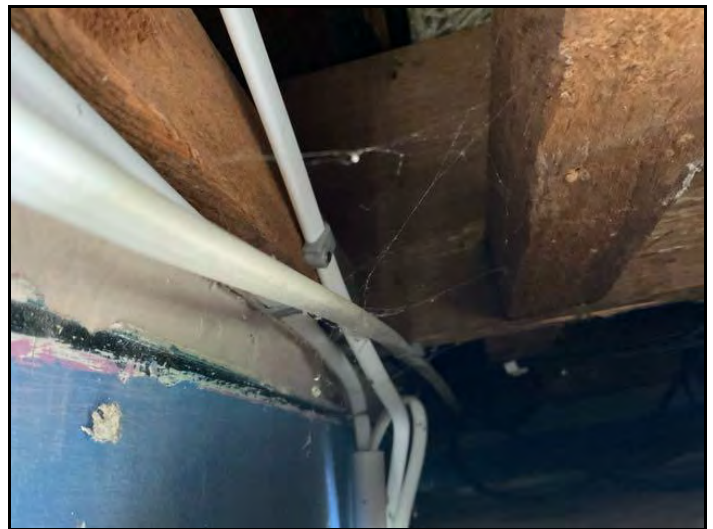
Sample Number	X002	Survey Type	MS
Location Ref	015	Product Type	Paper Product
Product	Debris to timbers & perimeter of room	Damage	High Damage
Area	Marlborough Community & Youth Centre	Surface Treatment	Unsealed AIB, encapsulated spray
Floor	1st Floor	Asbestos Type	Chrysotile
Room	IT Room & pool room	Identification	Cross Reference
Surveyor Name	Rob Letman	Quantity	65 m²
Asbestos?	Yes	Material Risk Score	8
Date	18/06/2024	Material Risk Band	Medium
Next Inspection	18/06/2025	Priority Risk Score	0
Action	Restrict access and remove by a licensed contractor

The asbestos material is currently in a poor condition and requires either removal or repair/encapsulation as soon as practically possible. The remedial works must be undertaken in accordance with current control of asbestos regulations 2012.

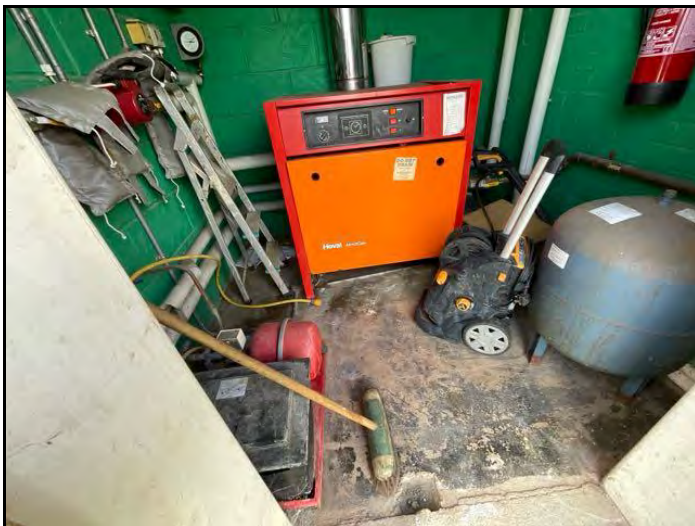
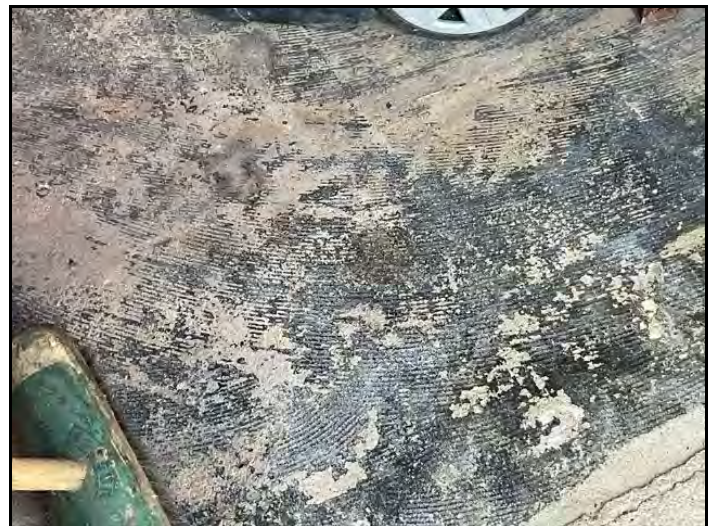
Sample Number	Presumed	Survey Type	MS
Location Ref	016	Product Type	Bituminous Product
Product	Adhesive to floor	Damage	Low Damage
Area	Marlborough Community & Youth Centre	Surface Treatment	Composite, plastics or resins
Floor	Ground Floor	Asbestos Type	Chrysotile
Room	Boiler	Identification	Presumed
Surveyor Name	Rob Letman	Quantity	1 m ²
Asbestos?	Yes	Material Risk Score	3
Date	18/06/2024	Material Risk Band	Very Low
Next Inspection	18/06/2025	Priority Risk Score	0
Action	Affix ID Labels & Manage as part of the management plan

Asbestos material is currently in a fair condition. Strongly recommended the material should have periodic inspections undertaken to manage the material in situ & where possible have asbestos warning stickers applied. An annual re-inspection asbestos survey is recommended. The ongoing management of the asbestos material will need to be undertaken in accordance with current control of asbestos regulations 2012.

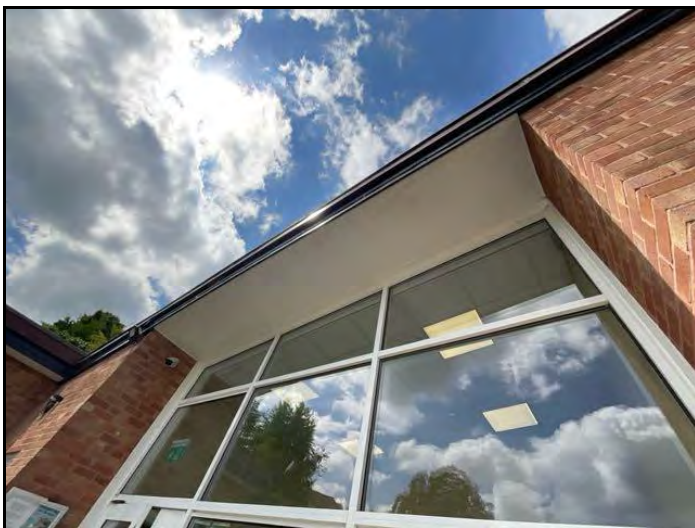
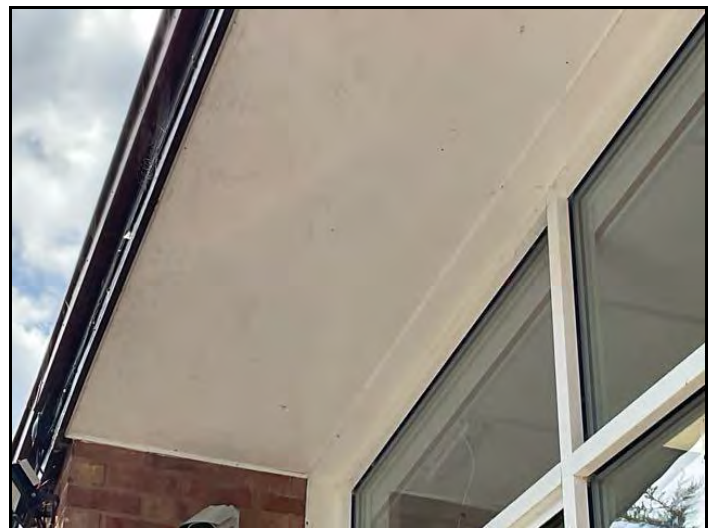
Sample Number	Strongly Presumed	Survey Type	MS
Location Ref	017	Product Type	Limited Access Gained
Product	Soffit board	Damage	Low Damage
Area	Marlborough Community & Youth Centre	Surface Treatment	Sealed AIB, spray, textile and thermal insulation, or asbestos cement
Floor	Ground Floor	Asbestos Type	Crocidolite
Room	Entrance canopy	Identification	Strongly Presumed
Surveyor Name	Rob Letman	Quantity	Non-quantifiable
Asbestos?	Yes	Material Risk Score	5
Date	18/06/2024	Material Risk Band	Low
Next Inspection	18/06/2025	Priority Risk Score	0
Action	Sample to confirm the presence of Asbestos prior to any refurbishment works

Asbestos material is currently in a fair condition. Strongly recommended the material should have periodic inspections undertaken to manage the material in situ & where possible have asbestos warning stickers applied. An annual re-inspection asbestos survey is recommended. The ongoing management of the asbestos material will need to be undertaken in accordance with current control of asbestos regulations 2012.
