Marlborough Town Council

Property Committee

Asbestos Management Survey for

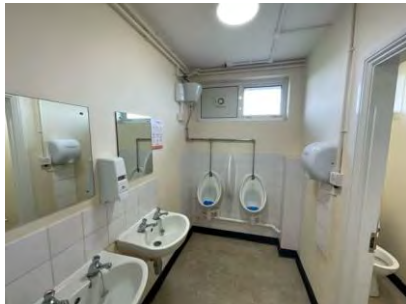
Marlborough Community & Youth Centre			
Location No	Location	Items	Photo
001	Basement, Music room	Floor: Carpetted / carpet tiled Walls: Plastered brick / block / concrete Ceiling: Concrete	 
003	Basement, Male w.c	Floor: Vinyl Linoleum Walls: Plastered brick / block / concrete Ceiling: Concrete

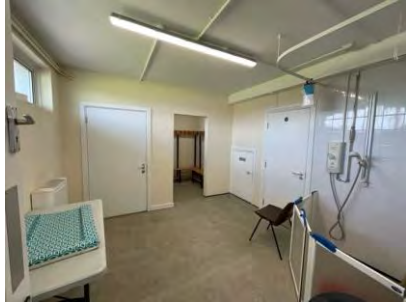
Marlborough Community & Youth Centre			
Location No	Location	Items	Photo
007	Basement, Changing area	Floor: Vinyl Linoleum Walls: Plastered brick / block / concrete Ceiling: Concrete

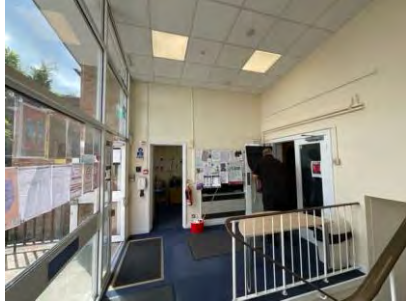
008	Ground Floor, Lobby area	Floor: Carpetted / carpet tiled Walls: Plastered brick / block / concrete Ceiling: Machine Made Mineral Fibre product

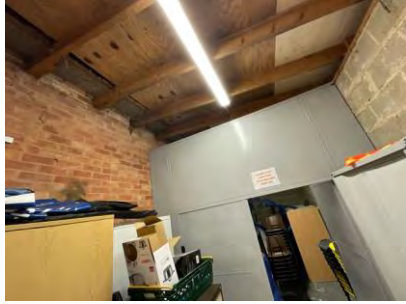
009	Ground Floor, Store	Floor: Carpetted / carpet tiled Walls: Plastered brick / block / concrete Ceiling: Stramit Board

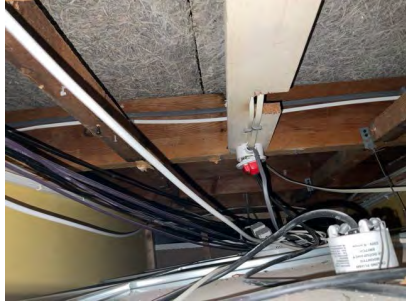
011	1st Floor, Ceiling void	Ceiling: Timber Upper ceiling: Stramit Board

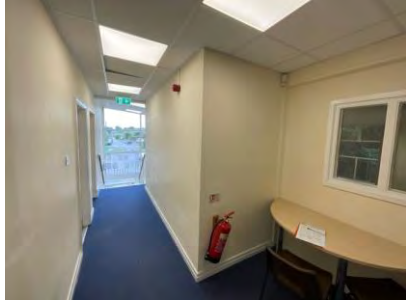
Marlborough Community & Youth Centre			
Location No	Location	Items	Photo
012	1st Floor, Landing	<p>Floor: Carpetted / carpet tiled</p> <p>Walls: Plastered brick / block / concrete</p> <p>Ceiling: Machine Made Mineral Fibre product</p>
